CLOSE CALL/HAZARD REPORT

Firefighter Struck by Fire Department Vehicle

10105 Jaydee Blvd, Fairfax Station

January 27, 2009

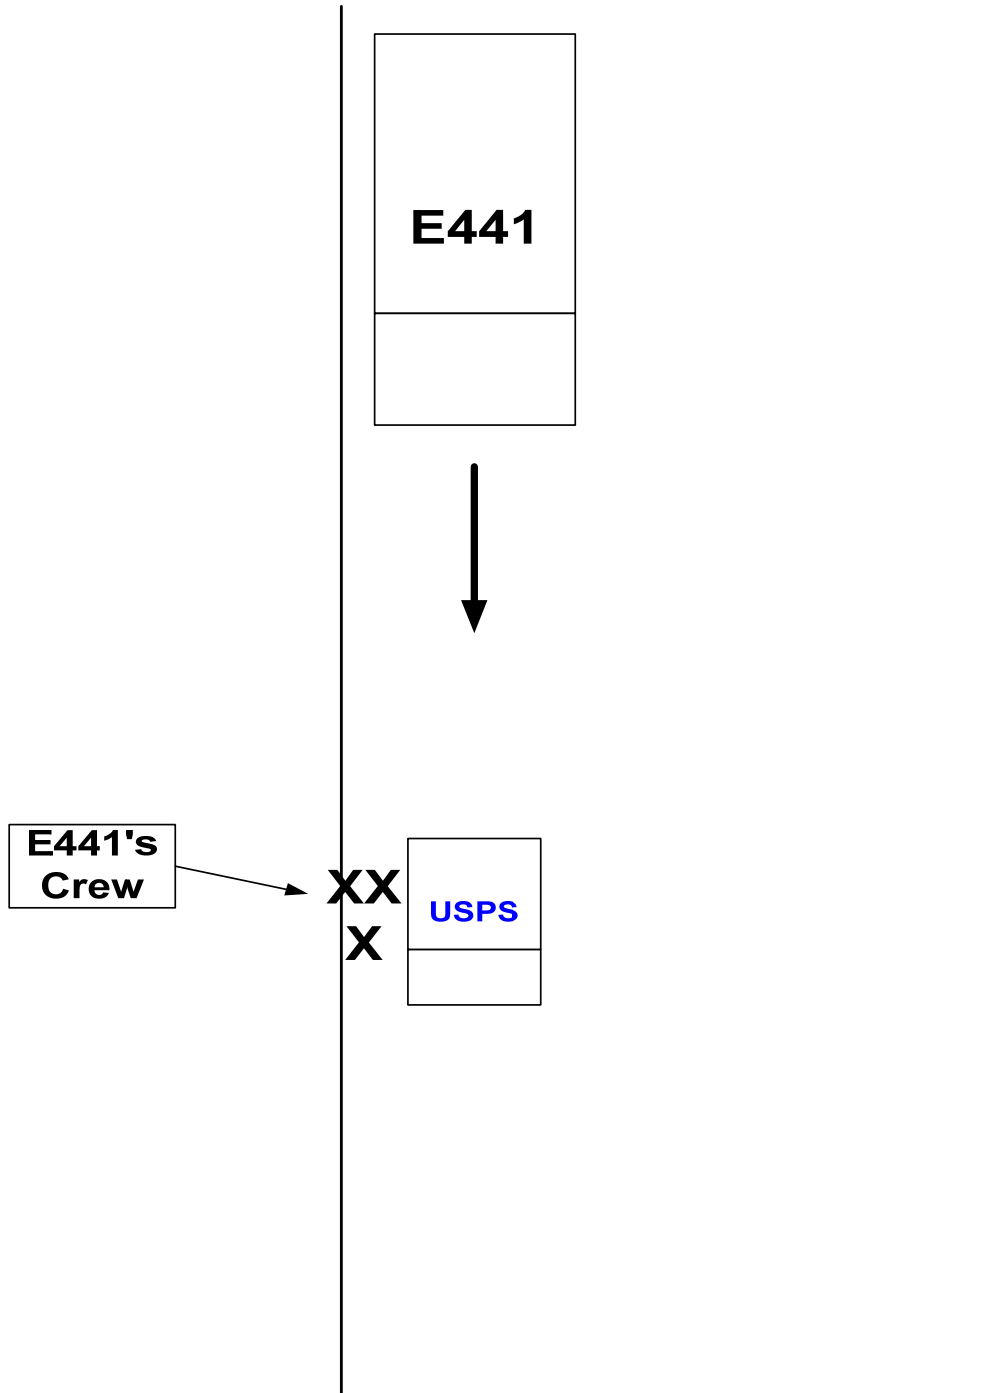
E441 Arrival on Scene

Engine 441 was positioned at the incident scene on the uphill side of an incline from the site of the injured person. The engine was parked parallel in the roadway within 50 feet of the postal vehicle near the injured person's location. The vehicle's wheels were left in a straight position and not turned towards the right side of the road.

The snow and ice covered road conditions were not taken into consideration when positioning the vehicle at the incident scene. The vehicle was parked in-line with the roadway and not turned to block traffic within the safety zone.

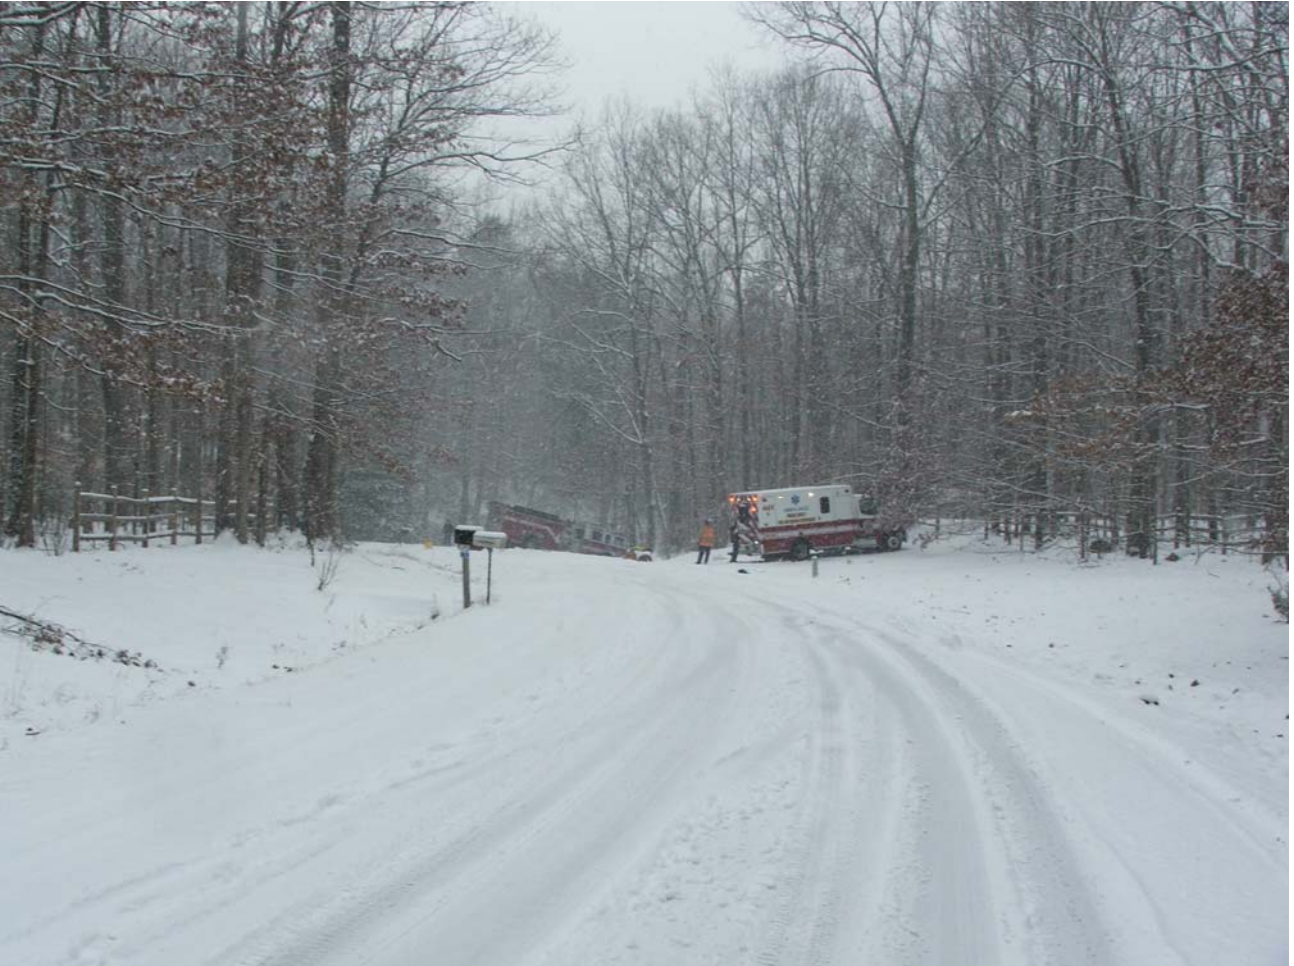
The rear of Engine 441 was just past the driveway where Medic 441 is located before it started sliding.

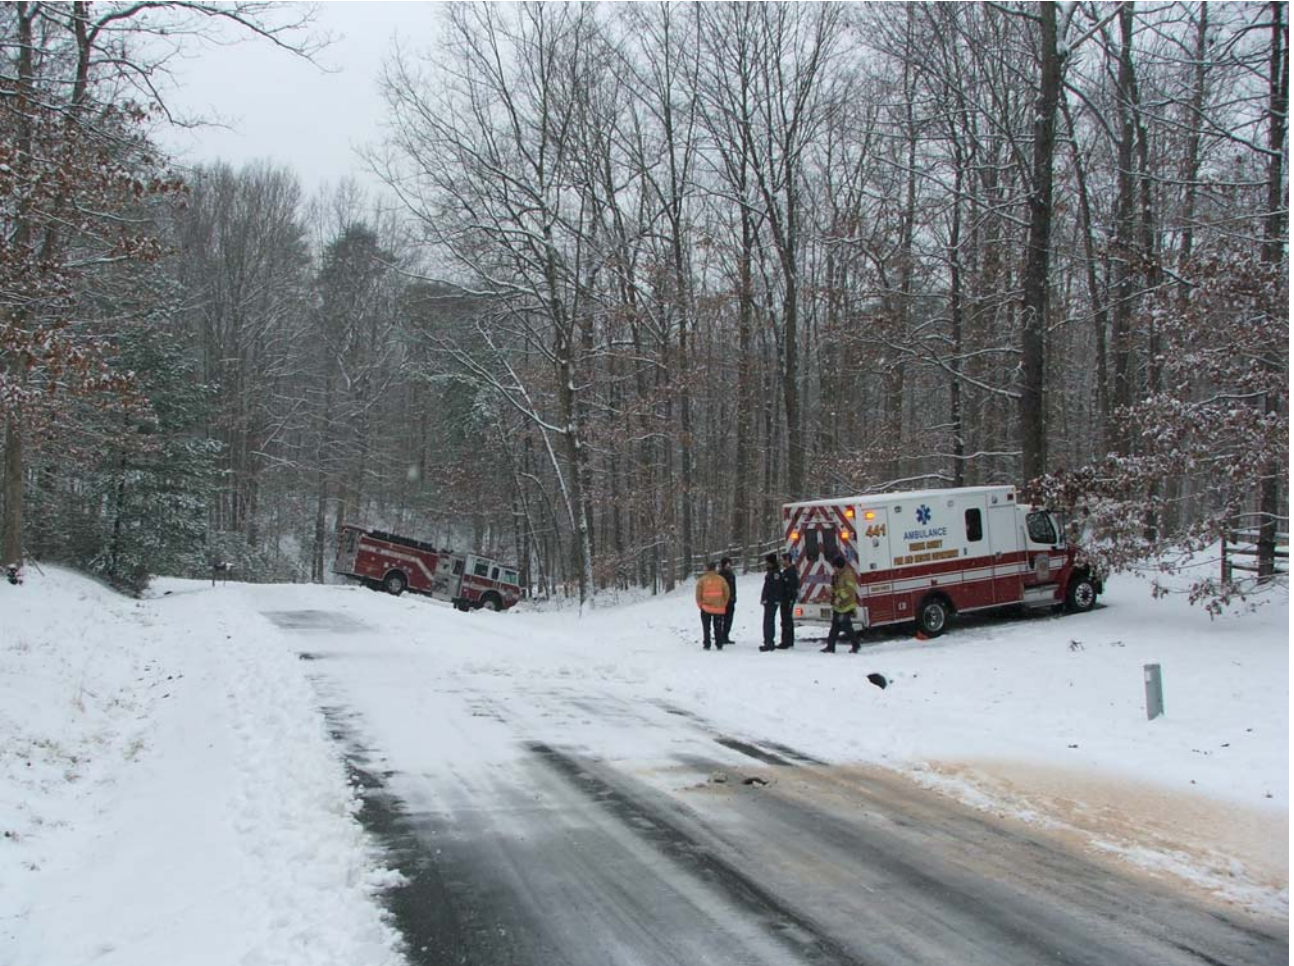
The scene after the road was plowed.

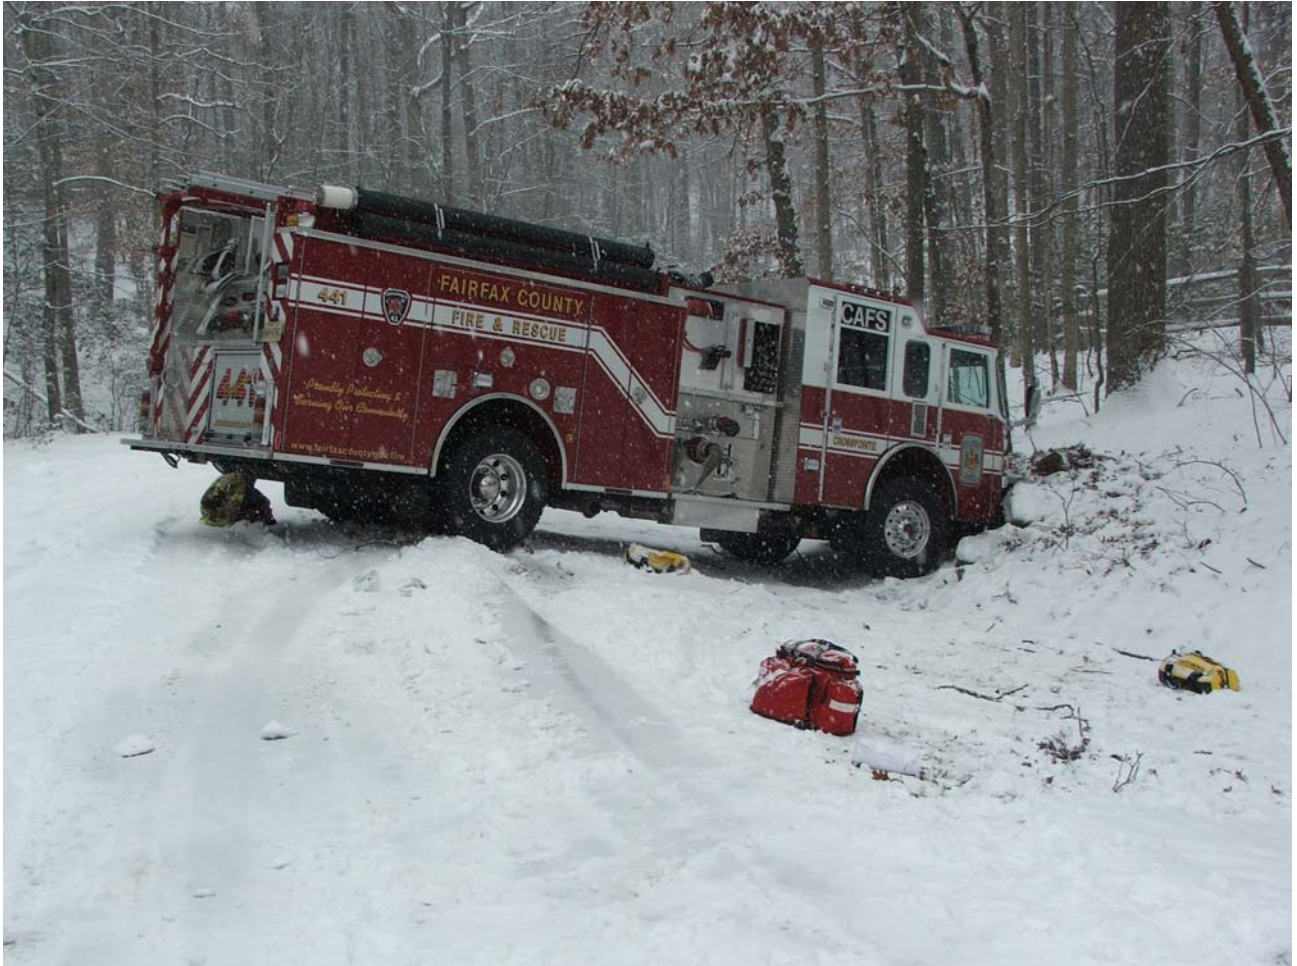
Engine 441's final location.

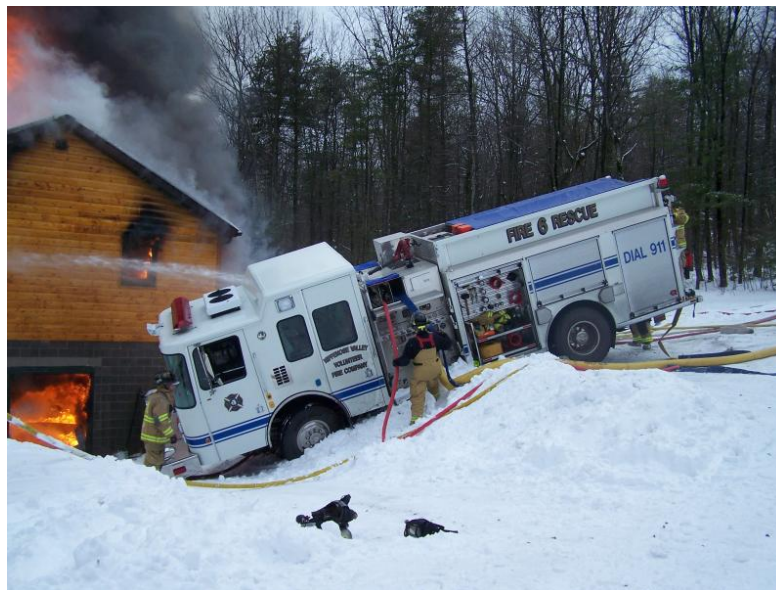
4. In February 2008, a Central Pennsylvania, Engine Company slid down a hill while pumping at a fire. It came to rest very near the well involved structure. (Photo below)
