## CLOSE CALL/HAZARD REPORT

MAYDAY EVENT / COLLAPSE  
10801 WINDCLOUD CT  
JUNE 2, 2006

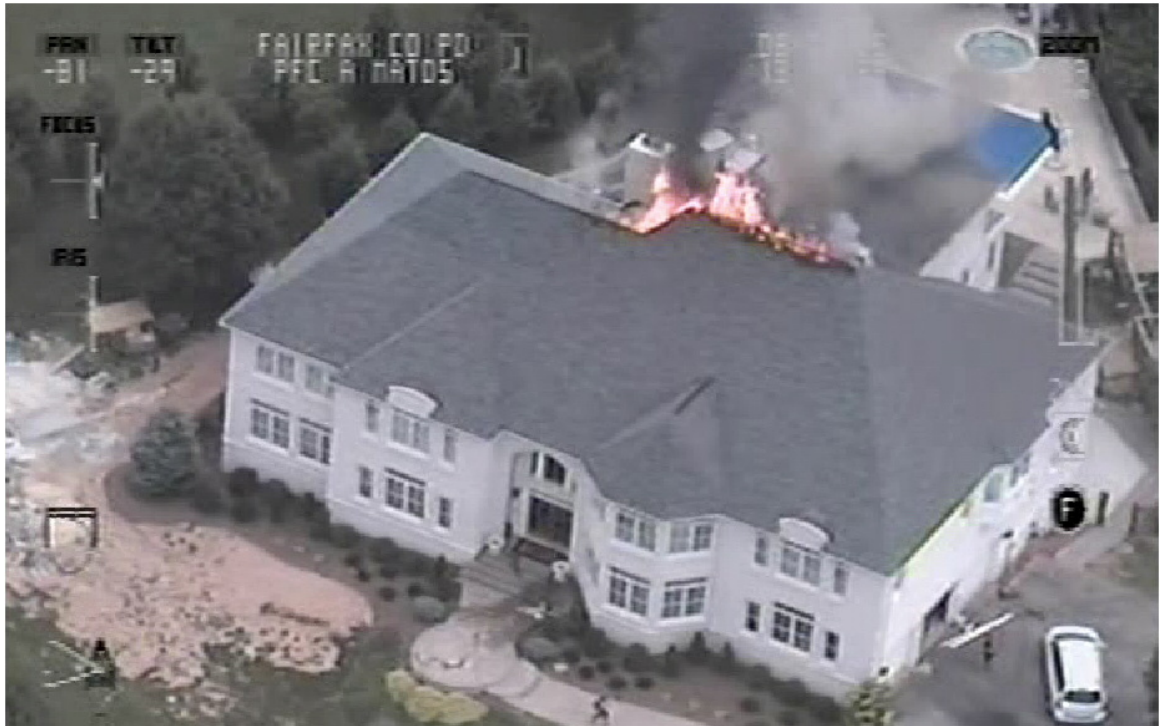
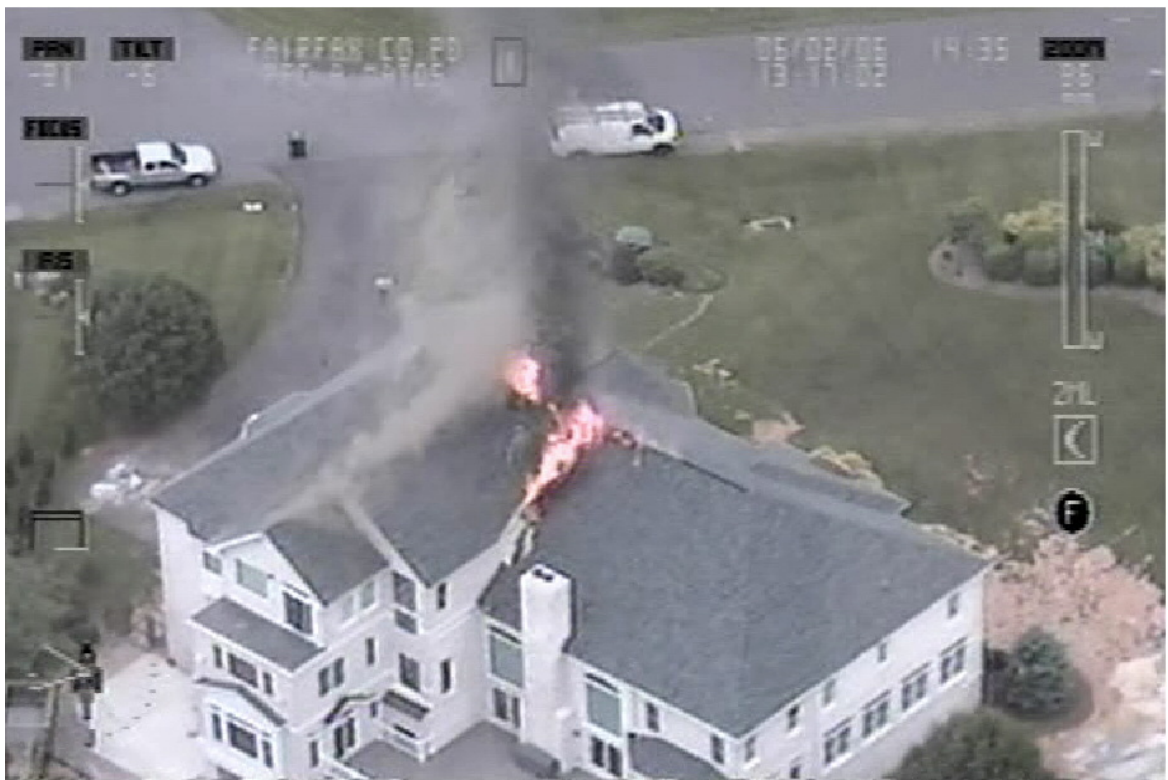
Views of sides A and C from Fairfax County Police Helicopter 'Fairfax One'. Fairfax One arrived overhead of the incident with their camera on approximately 5 minutes prior to the arrival of BC402 and F434.

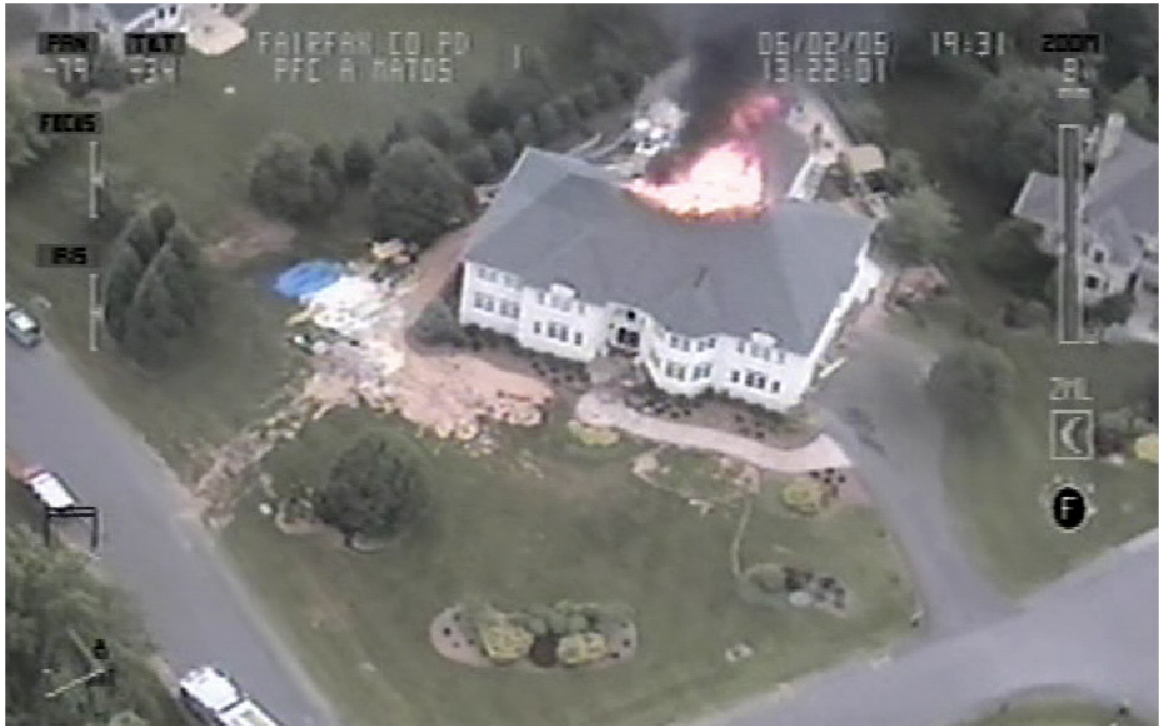
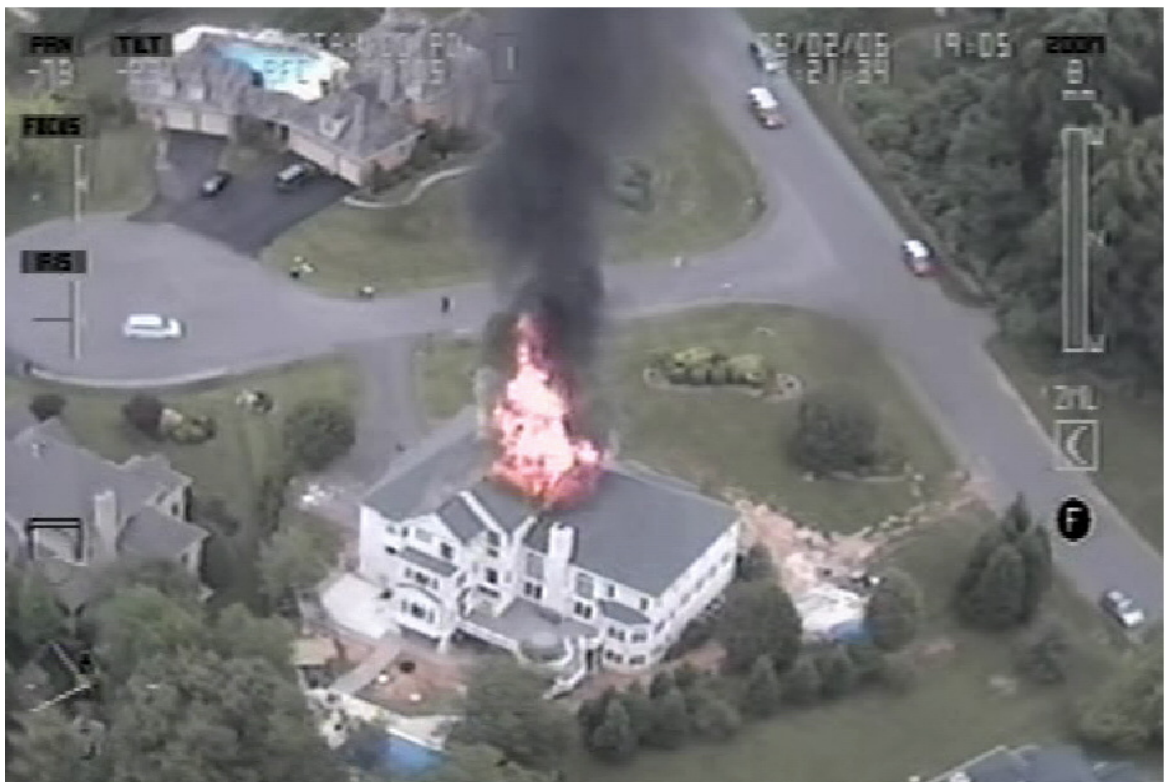
Views of sides A and C from Fairfax County Police Helicopter 'Fairfax One' as BC402 and E434 arrive on the scene. Fairfax One has been overhead for approximately 5 minutes.

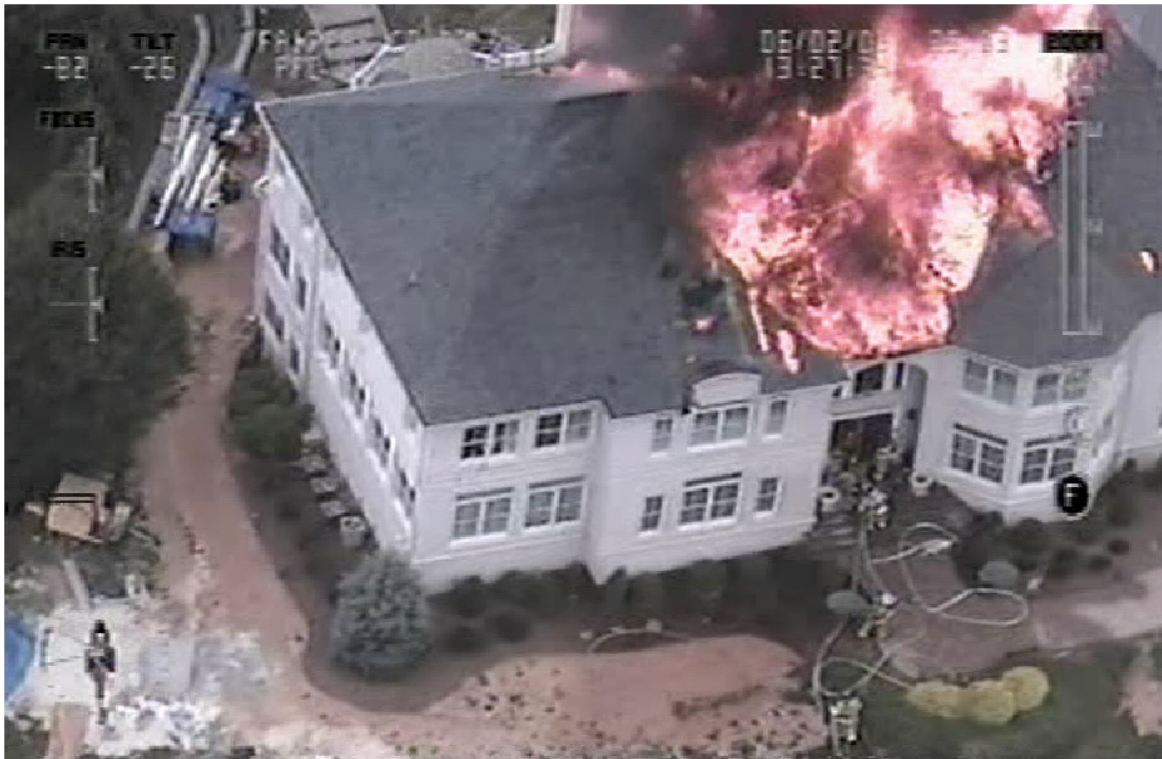
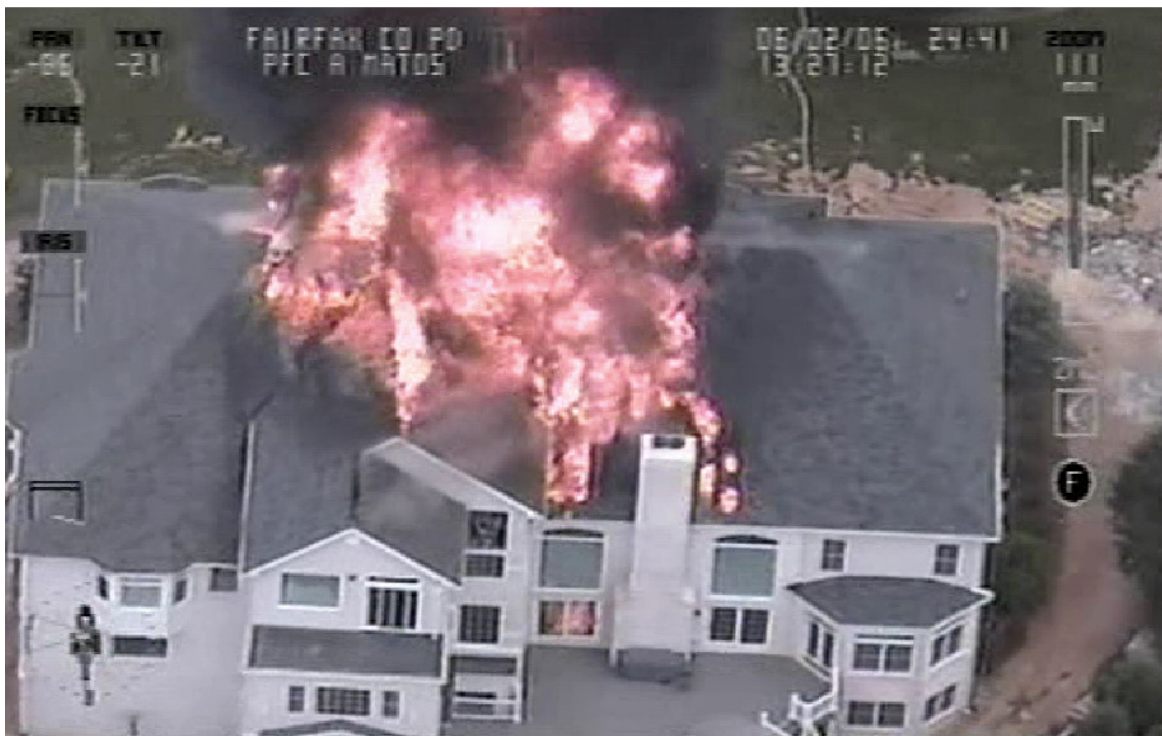
The initial collapse occurred in and around the foyer and stairs. This area had the largest truss span in the building and was located below where the bulk of the fire was venting through the roof. In addition to the large open area, a very large chandelier was suspended from the ceiling in the foyer.

Views of sides A and C from Fairfax County Police Helicopter 'Fairfax One' immediately following the collapse. Fairfax One has been overhead for approximately 10 minutes, BC402 and E434 have been on the scene for approximately 5 minutes.

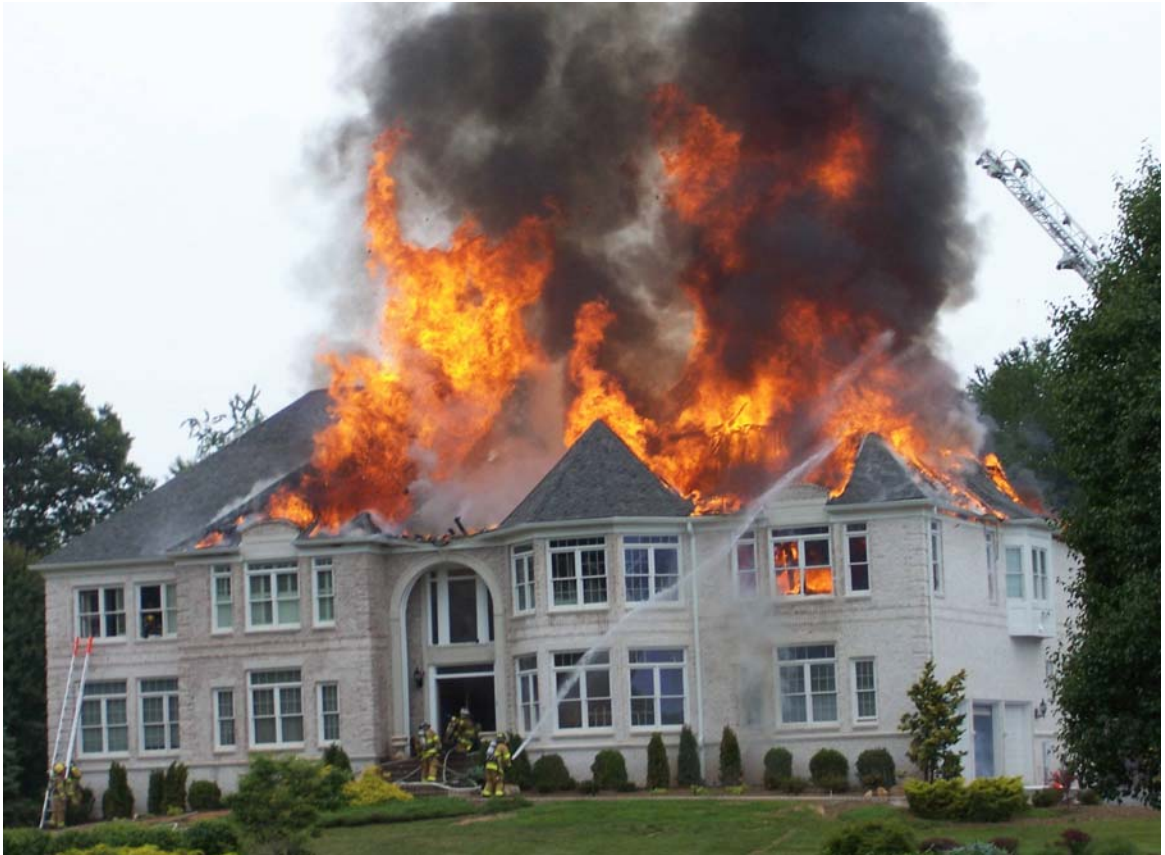
View from the street of the house prior to E434 exiting the structure.

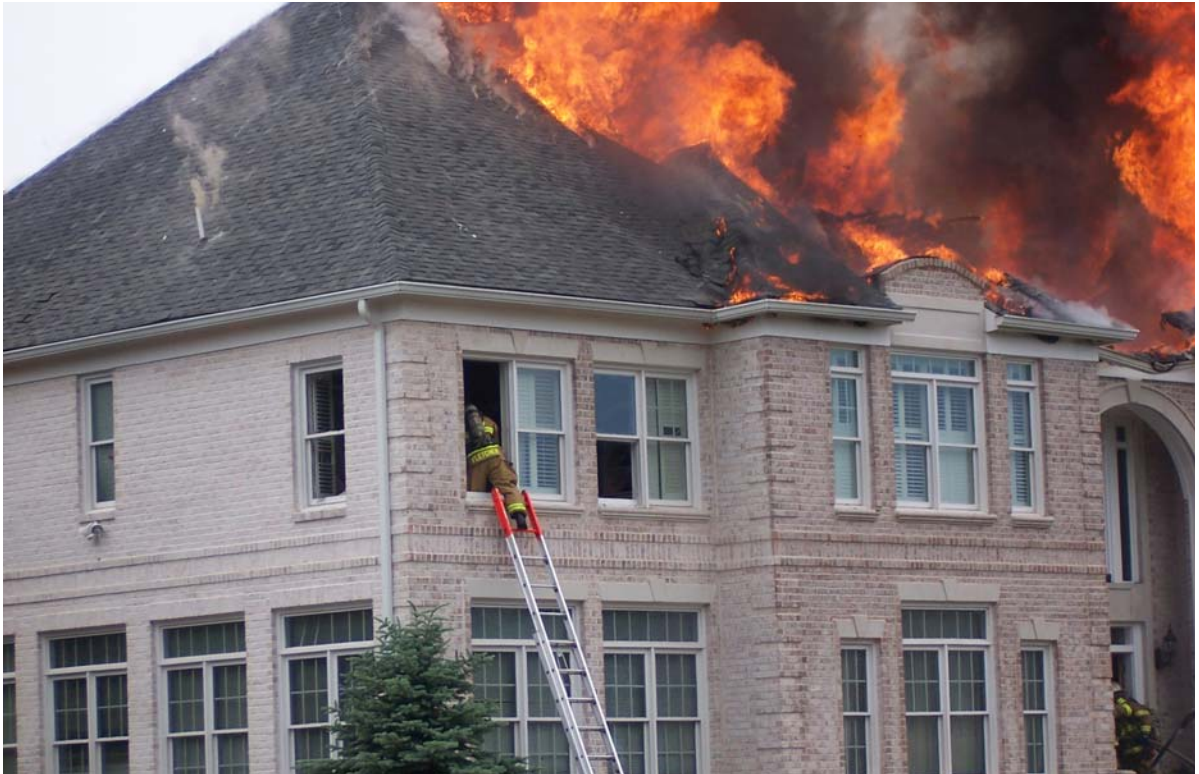
Crewmember from E434 exits the second floor via 24-foot ladder.

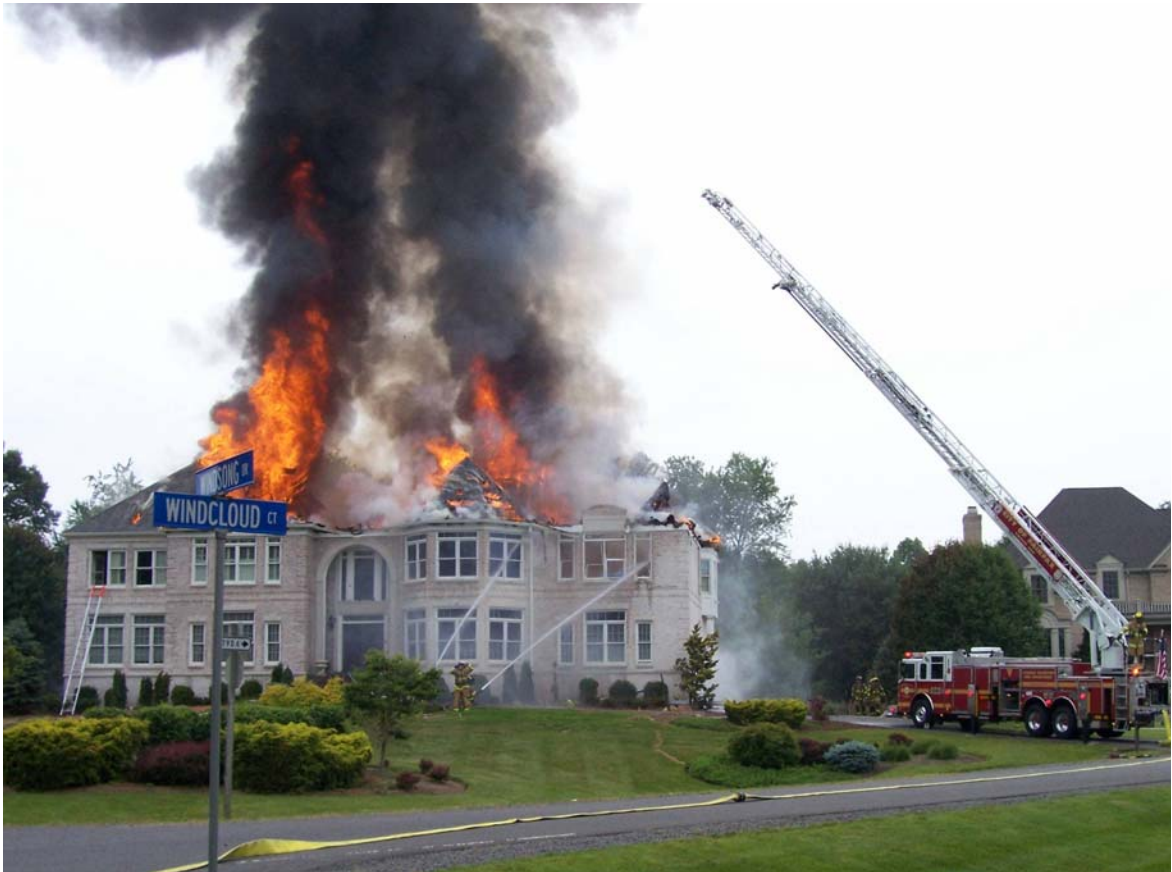
T403 prepares to operate the ladder pipe.
